Vehicle Safety Inspection Program Bulletin

ASED-018

RE: **Floor, Trunk Pan, Frame & Unibody Repair**

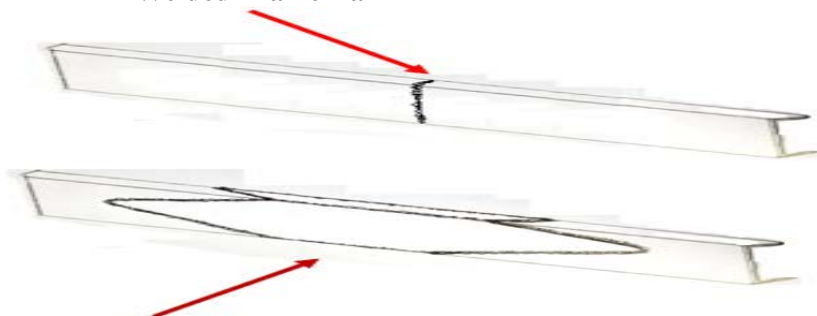
Welded Frame Rail With “Fish-Plate” Installed

Frame and Unibody - Frame repair must be welded and reinforced by “**fish-plate**” when sectioning or joining frame rails. Sub-Frame repair is not recommended by most manufacturers, and should be only be repaired by replacement rather than by straightening or welding. Bolt on fenders, hoods, doors, etc are generally not structural components of unibody construction. Welded/bonded components are generally structural.
